Case Study: MFC in White Top Liner Lab Study

Improved surface strength & ply-bond while increasing filler

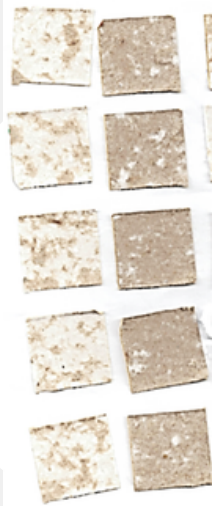
- Top Layer: 40 g/m², 0% MFC, 26% filler
- Base Layer: 90 g/m², 0% MFC

- ✓ Reference case showed delamination at the interface between white and brown layers.
 - ✓ Filler increase with no MFC addition showed delamination in the white layer.
- ✓ Filler increase with 4% MFC addition in the white layer showed delamination in the base layer.
 - ✓ MFC gave improved surface strength and ply bond while enabling cost savings through replacing fibre with filler.
 - ✓ Estimated 10-12 EUR/t cost saving.

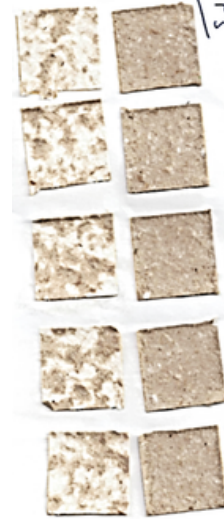
Pass in Top Layer (+4% MFC)

- Top Layer: 40 g/m², **4% MFC**, **38.5% filler**
- Base Layer: 90 g/m², 0% MFC
